STRUCTURAL SURVEY & RECOMMENDATIONS

Reference: Sterling Town Hall
Sterling, Massachusetts

The TOWN OF STERLING 1835 TOWN HALL

DRAFT TOPOGRAPHIC PLAN
 OLD TOWN HALL SITE
 STERLING, MASS.
 PREPARED FOR
 THE TOWN OF STERLING, MASS.
 OCTOBER 18, 2011

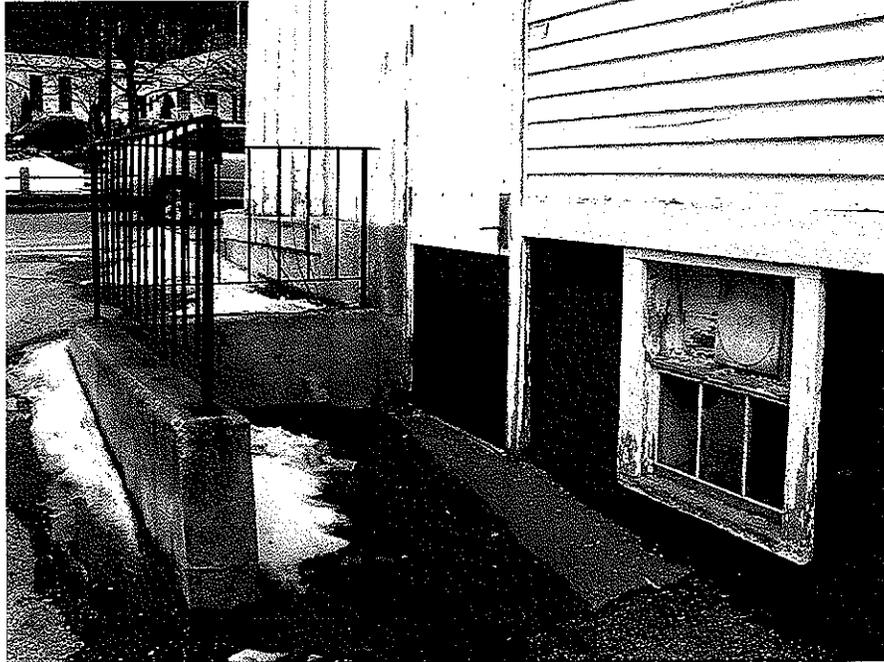
STAIR EXIT DOOR AND AREAWAY

- Door Boarded Up and Steel Plate Added
- Cracked Concrete Wall
- Rusting Metal Railing
- Broken Basement Window Boarded Up
- Brick Missing Upper Right of window Opening

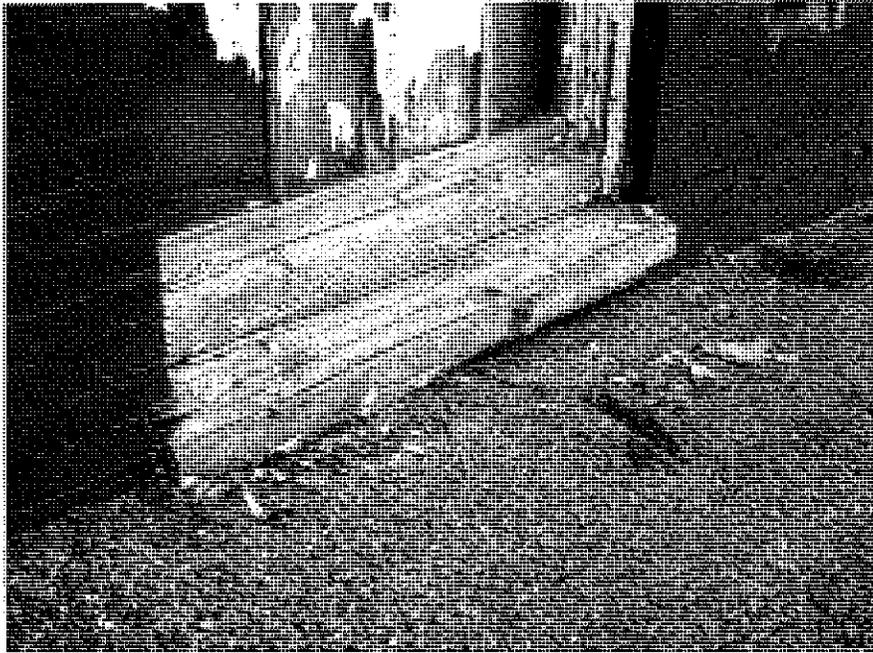
BASEMENT WINDOW SOUTH ELEVATION

- Rotted Wood Window Sill
- Paint Failure at Window
- Broken / Missing Glazing Putty

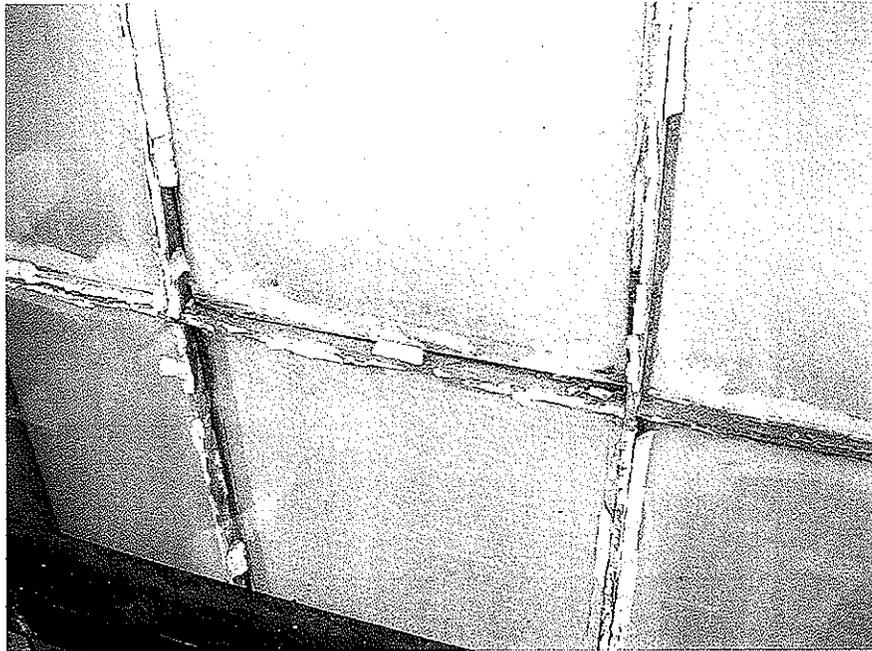
FIRST FLOOR WINDOW SOUTH ELEVATION
• Broken / Missing Glazing Putty

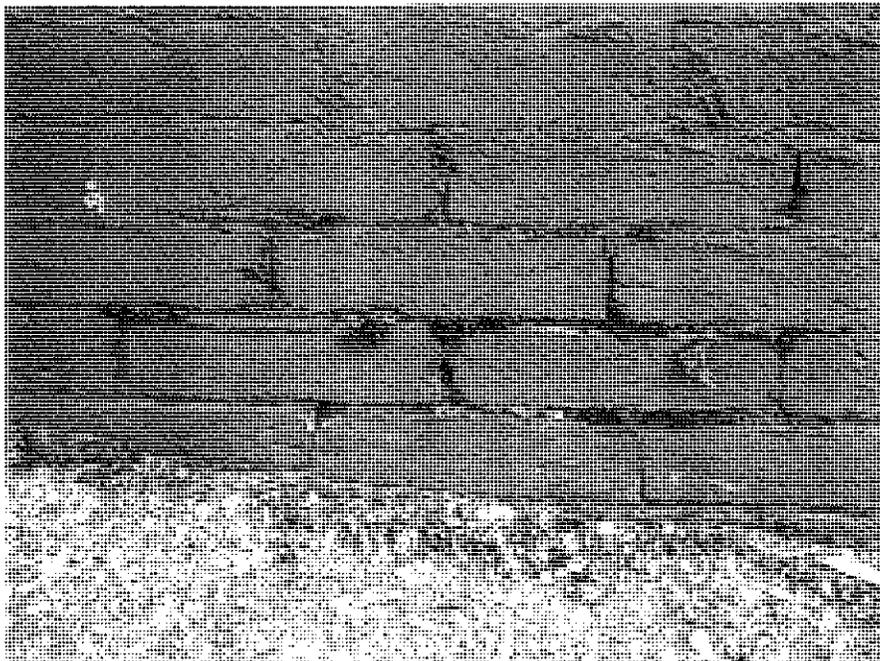
FIRST FLOOR WINDOW SOUTH ELEVATION
• Moss Growing in Mortar Joints

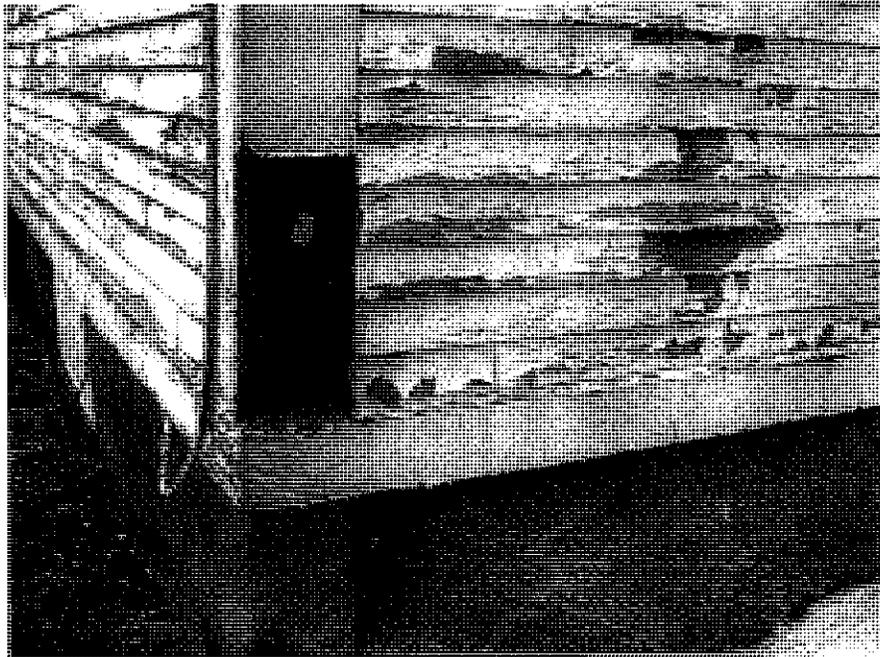
WOOD CORNERBOARD / SIDING NORTHEAST BUILDING CORNER

- Paint Failure at Clapboard Siding
- Missing Cornerboard Trim

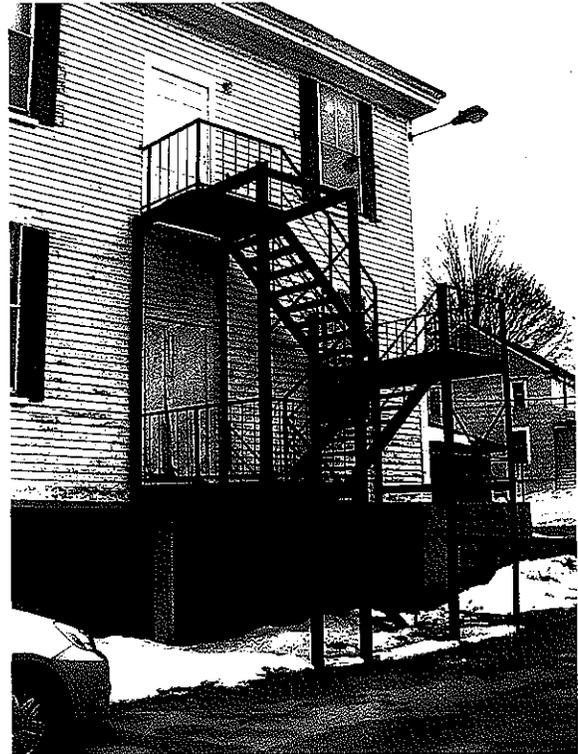
STEEL FIRE ESCAPE

- Steel Supports in Contact with Ground
- First Floor Door Boarded Up
- Non-Historical Light Fixtures

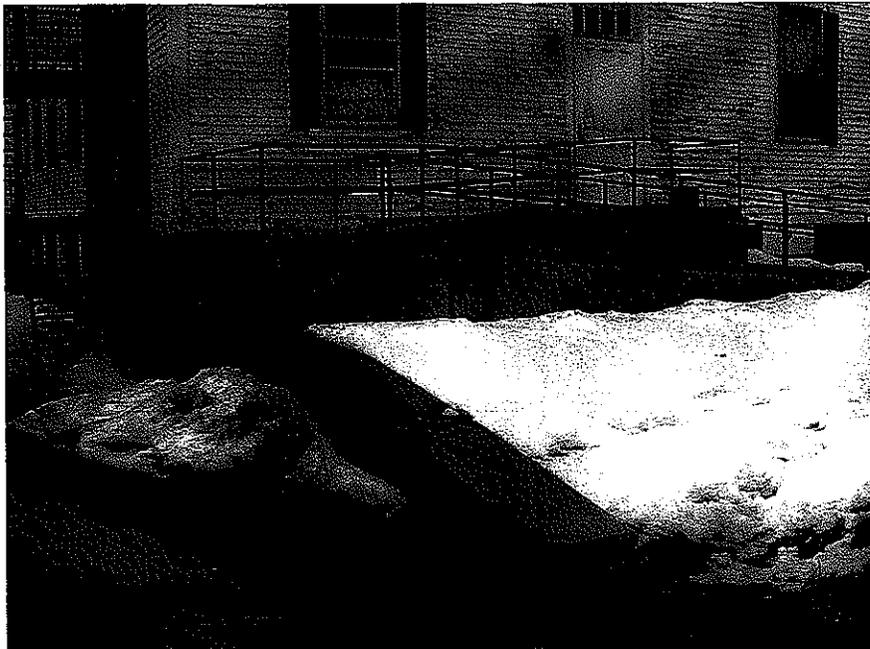
STONE / CONCRETE RETAINING WALL

- Broken Concrete
- Exposed Reinforcing Bar
- Loose / Broken Stone Mortar Joints

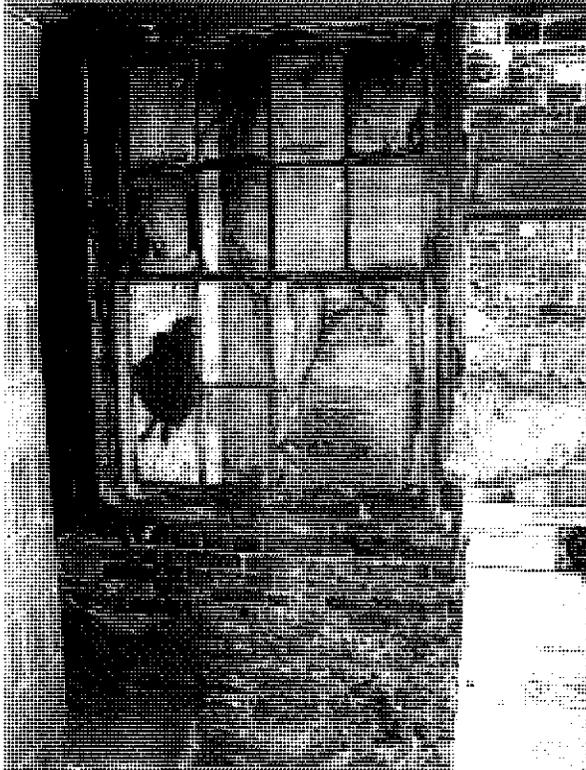
BASEMENT WINDOW

- Broken, Deteriorated Wood Window
- Moisture Damage at Masonry below Window

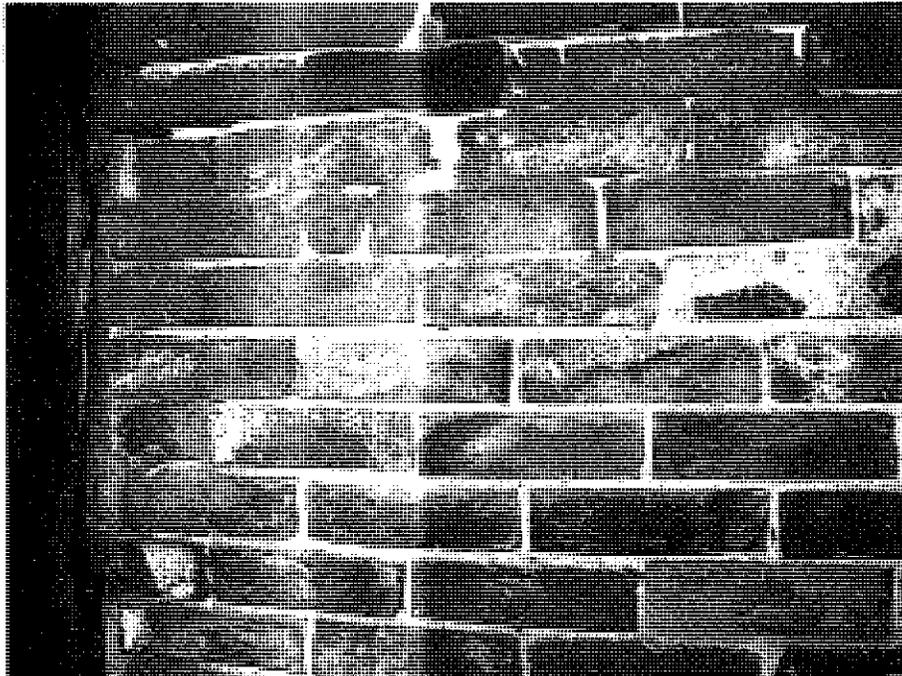
BASEMENT BRICK INTERIOR BEARING WALL

- Deteriorated and Missing Mortar

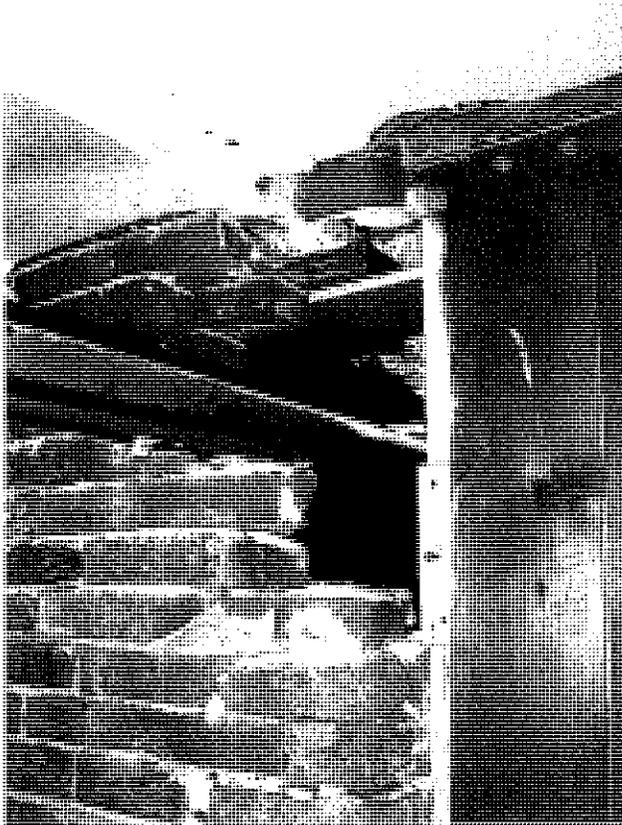
BASEMENT BEARING WALL

- Brick Removed for Pipe Installation
- Missing / Deteriorated Mortar

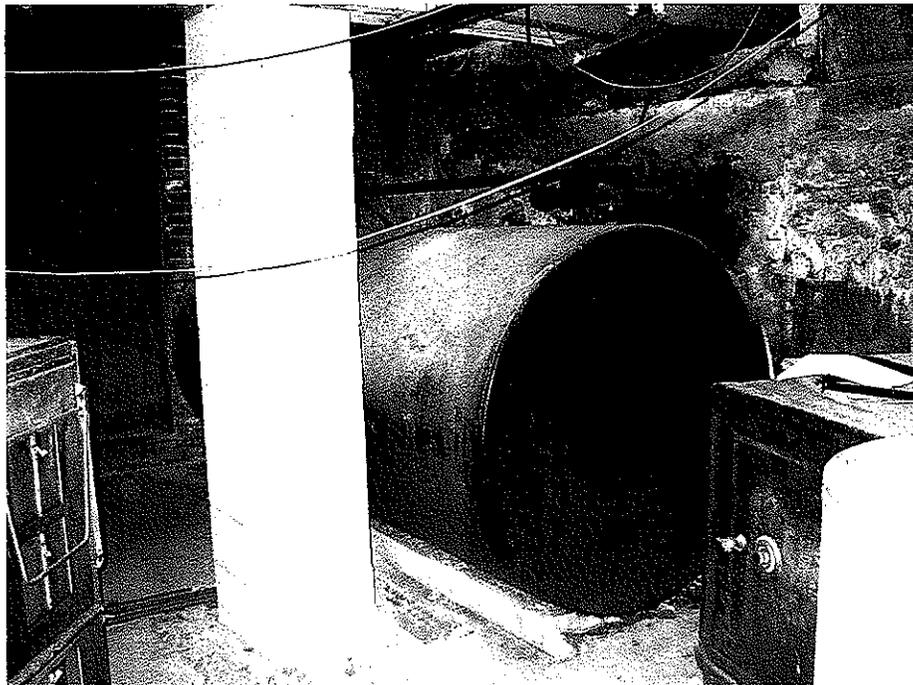
BASEMENT ABANDONED FUEL OIL TANK

- CMU Supplemental Pier
- Rubble Stone Foundation Intact

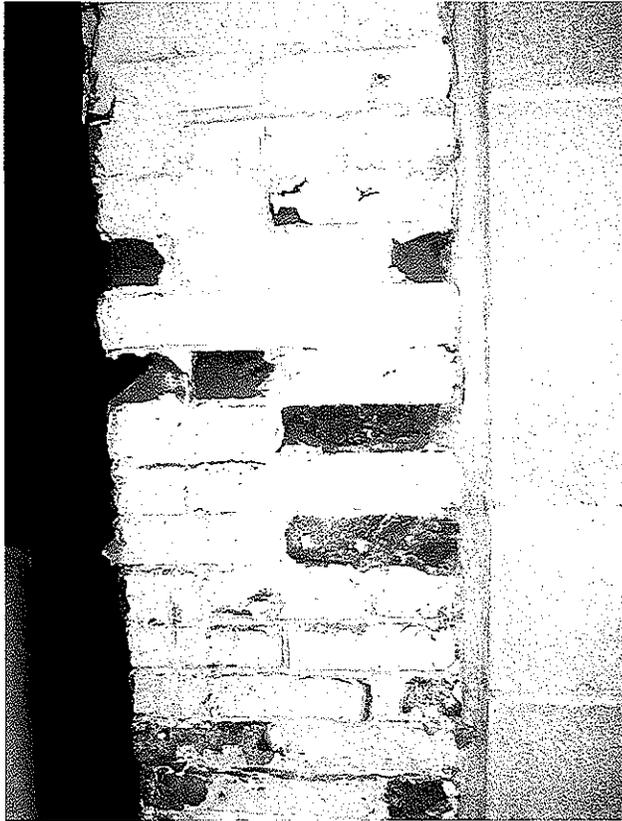
BASEMENT COLUMN REPAIR

The majority of the existing vertical supports are comprised of hollow CMU piers that either replaced or flank original brick masonry piers. Two remaining piers support a steel beam along the west edge of the boiler room, and are deteriorated, with the worst of the damage at their bases.

- Deteriorated Brick Pier
- Supplemental CMU Pier

These damaged piers should be removed and replaced with hollow steel columns. During the column replacement, footing conditions should be verified and insufficient footings replaced as required.

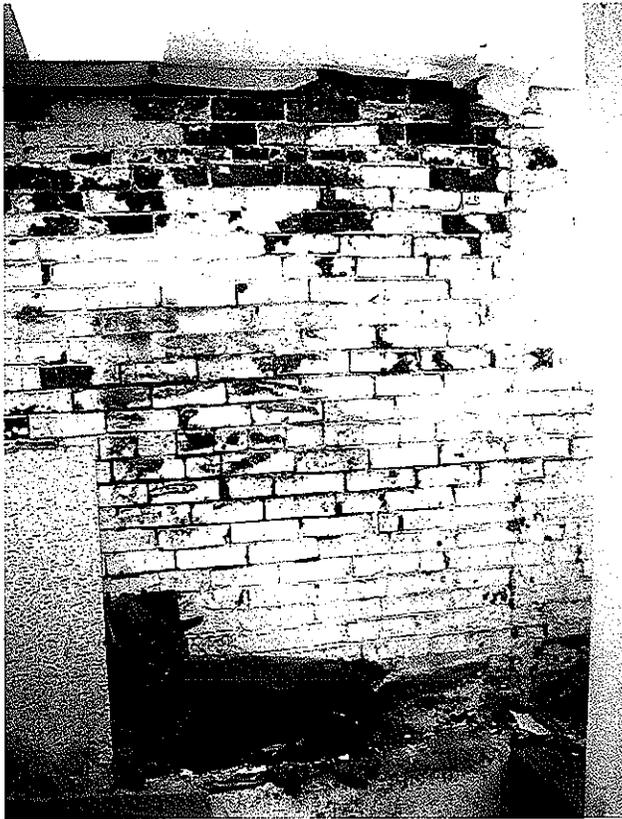
FOUNDATION WALL AT BASEMENT STAIR

- Missing and Deteriorated Mortar Joints
- Missing, Flaking Paint

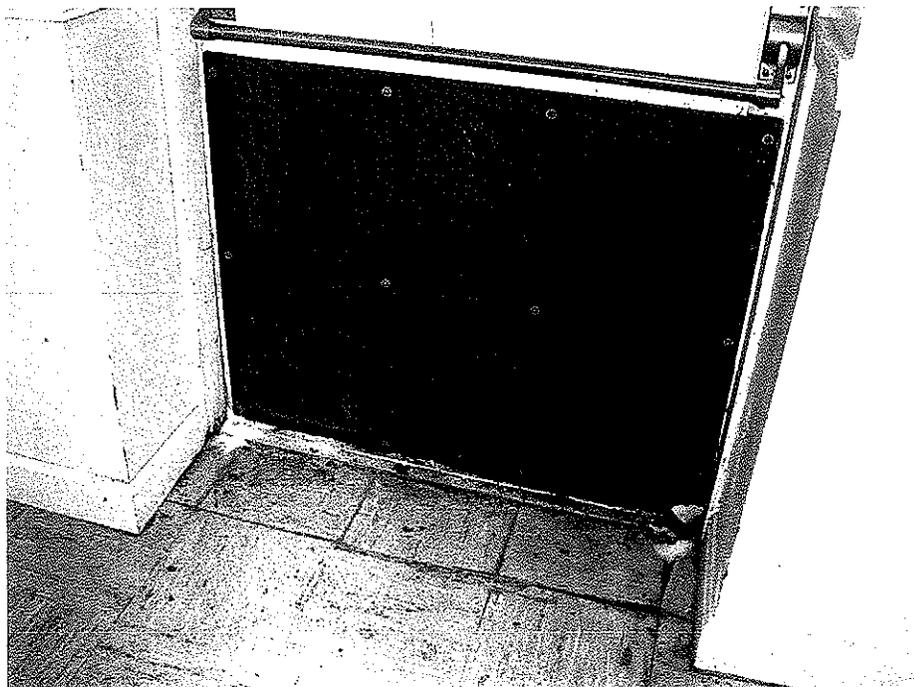
STAIR EXIT DOOR

- Plywood Covered Door
- Rusting Steel Plate Reinforcing
- Moisture Damage. Buckling Vinyl Tile

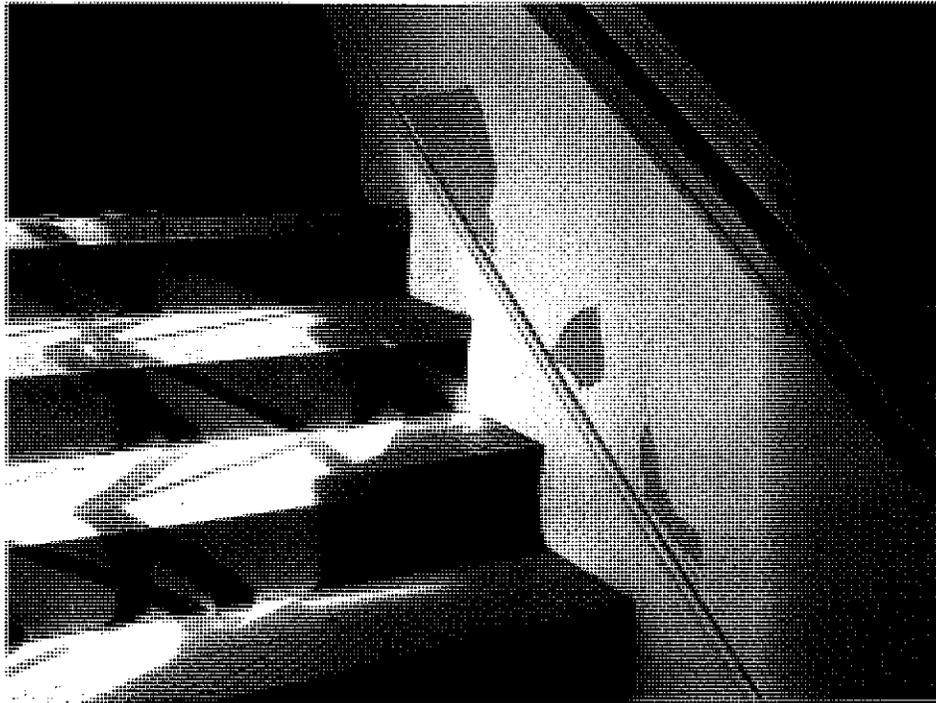
EXIT STAIR

- Loose, Spalling Paint
- Vinyl Stair Treads and Risers

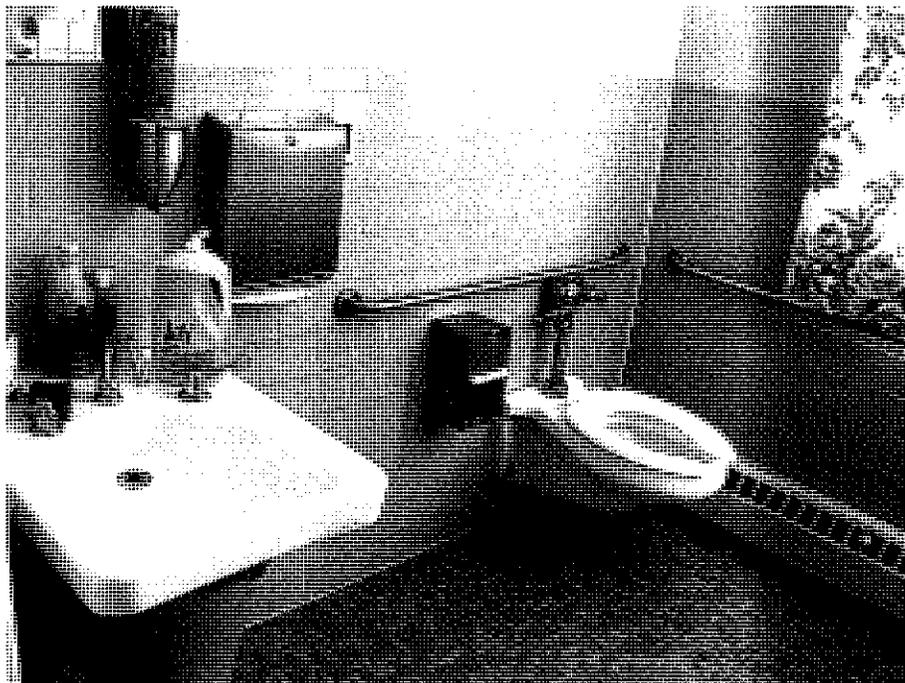
FIRST FLOOR MEN'S ROOM

- Non-Accessible / Compliant Toilet Accessories

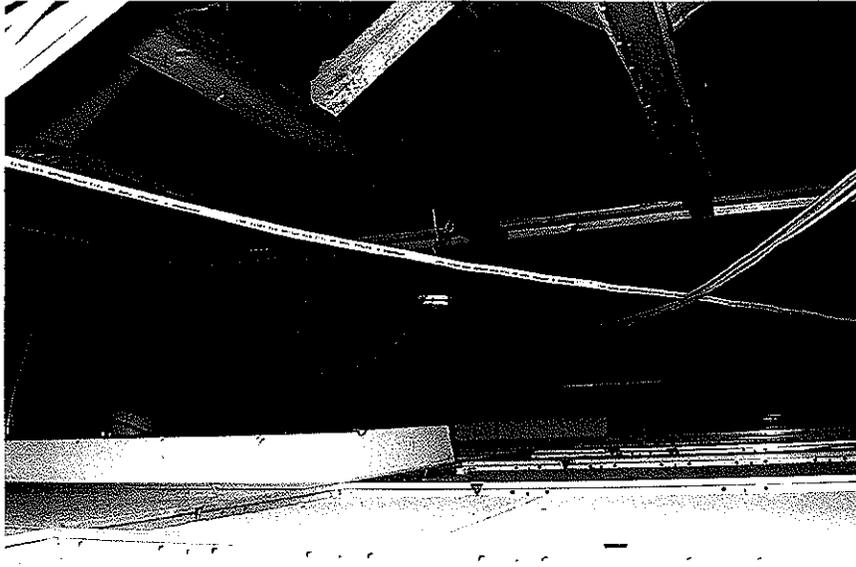
FIRST FLOOR MEETING ROOM CEILING PLENUM

- Previously Installed Suspended Ceiling / Lighting
- Remaining Furring from Original Ceiling Finish
- Original Column Capital Concealed Above Ceiling
- Loose Electrical Wiring
- Plenum Smoke Detector

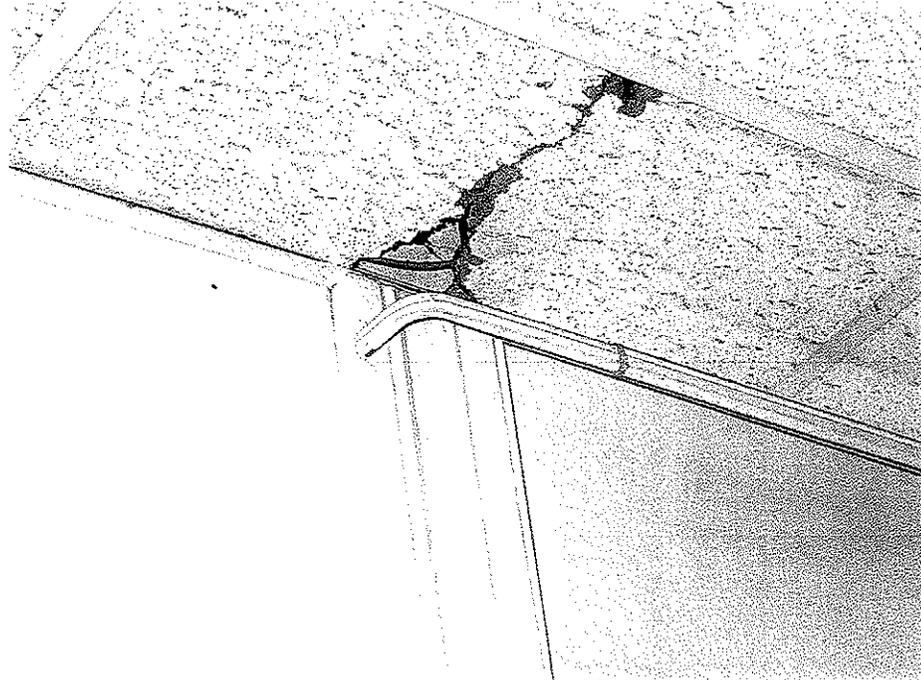
FIRST FLOOR MEETING ROOM WINDOW HEAD

- Wood Window Trim at Suspended Ceiling
- Suspended Ceiling Bisects Glass Window

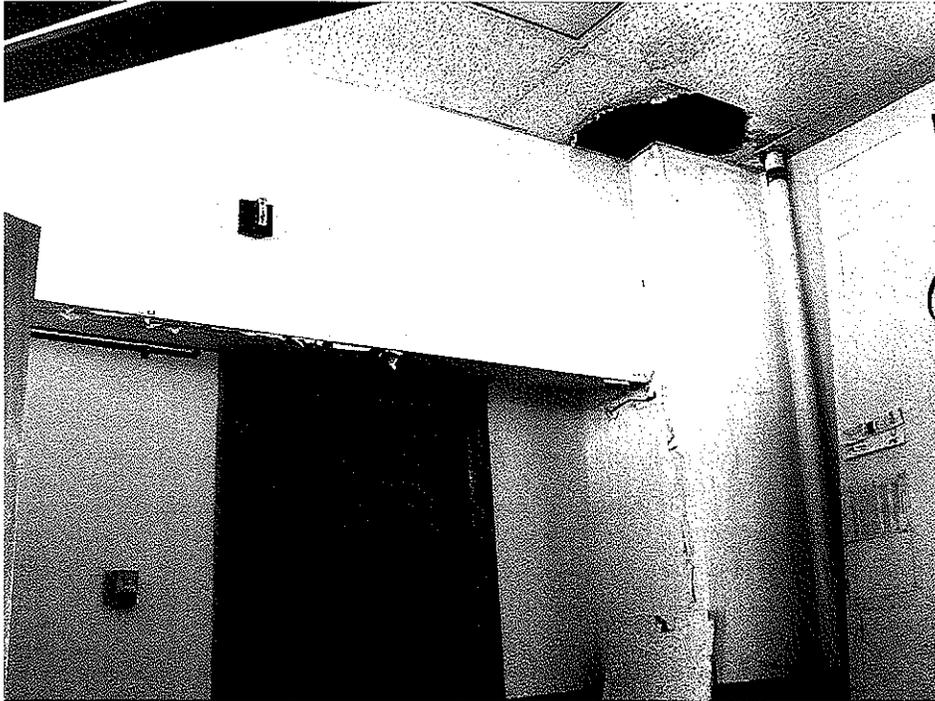
SECOND FLOOR MEETING ROOM

- Previous Water Damage Near Chimney

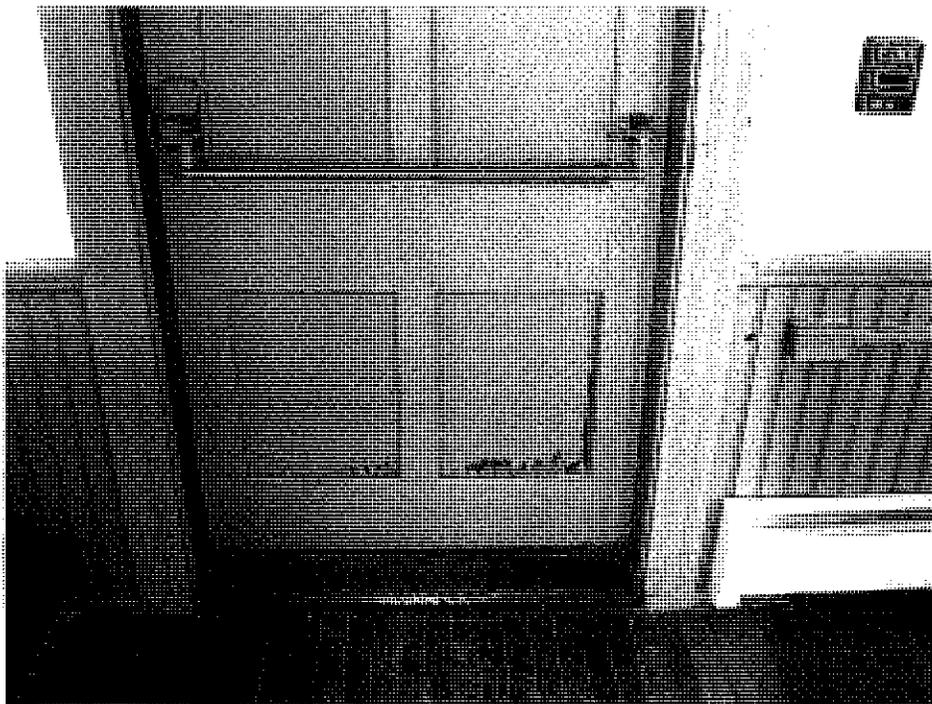
SECOND FLOOR FIRE ESCAPE EXIT DOOR

- Moisture Damage at Lower Door
- Wood Wainscoting
- Previously Installed Hydronic Baseboard

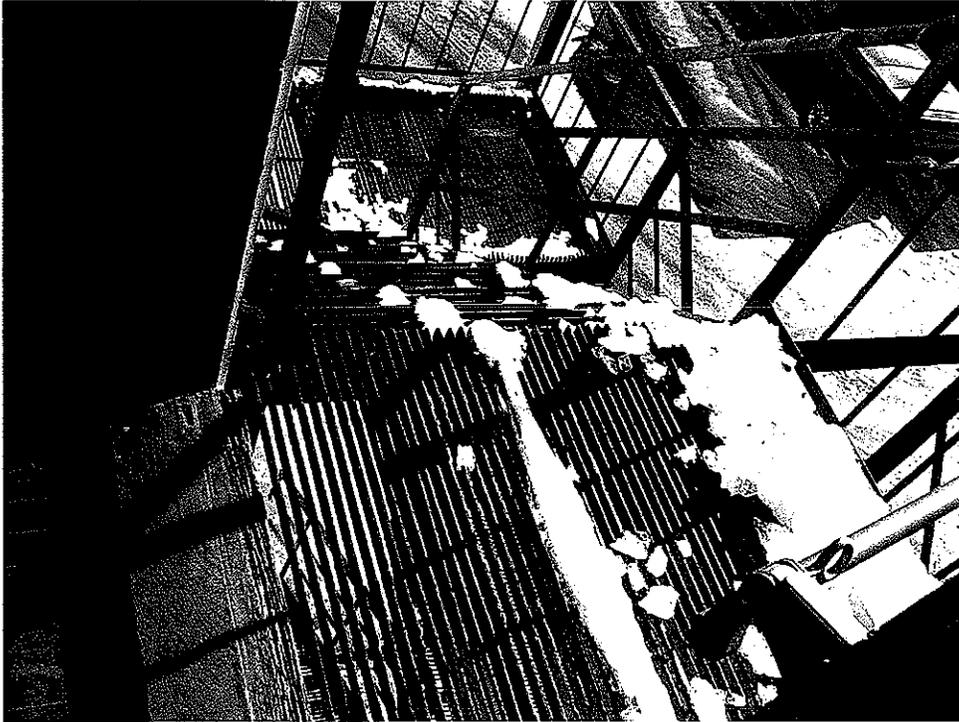
SECOND FLOOR FIRE ESCAPE

- Snow and Ice Falls from Roof Obstructing Exit
- Wood Will Partially Rotted

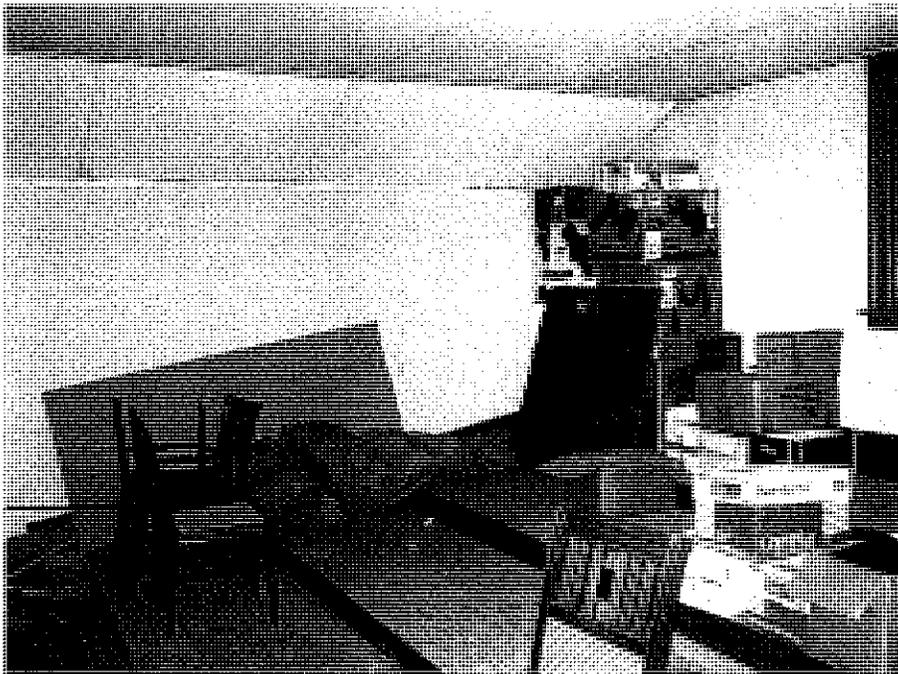
BALCONY

- Board and Batten Ceiling
- Original Stepped / Tiered Floor

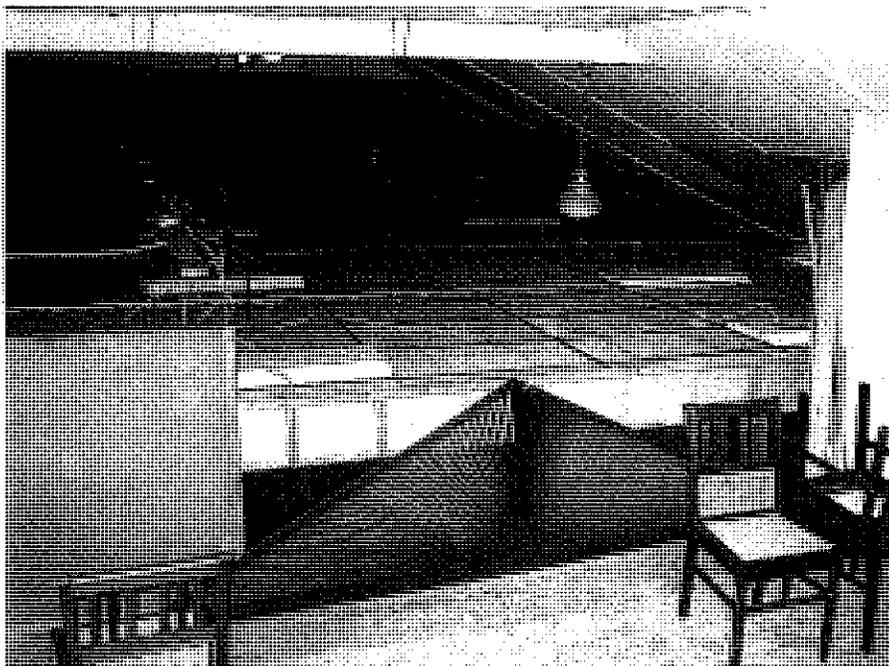
BALCONY

- Original Ceiling Above Suspended Ceiling
 - Original Type Light Fixtures
- Timber Truss Tie Rod and Cable Repairs
