STRUCTURAL SURVEY & RECOMMENDATIONS

Reference: Sterling Town Hall
Sterling, Massachusetts

The TOWN OF STERLING 1835 TOWN HALL

DRAFT TOPOGRAPHIC PLAN
 OLD TOWN HALL SITE
 STERLING, MASS.
 PREPARED FOR
 THE TOWN OF STERLING, MASS.
 OCTOBER 18, 2011

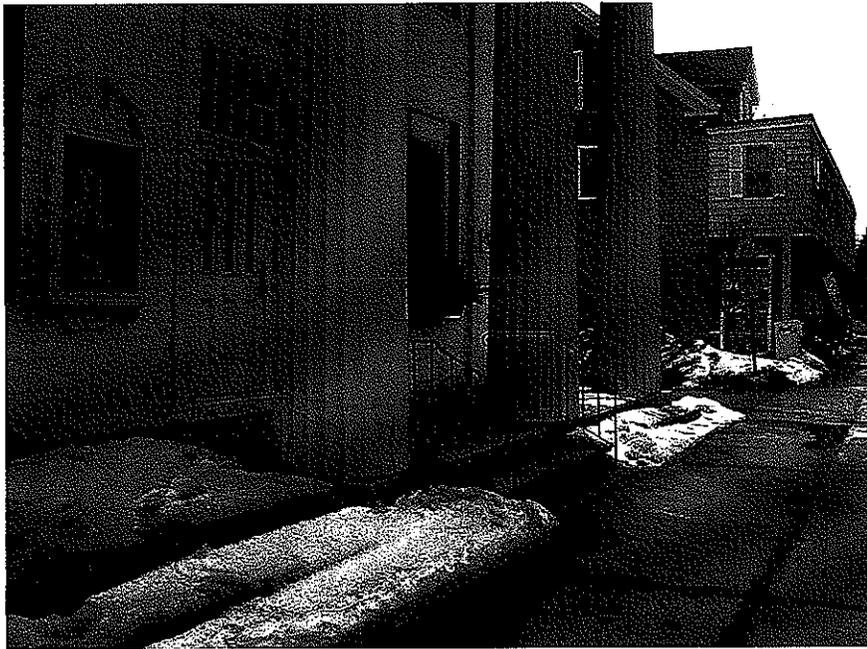
MAIN ENTRANCE PORTICO

- Recess Granite Below Columns

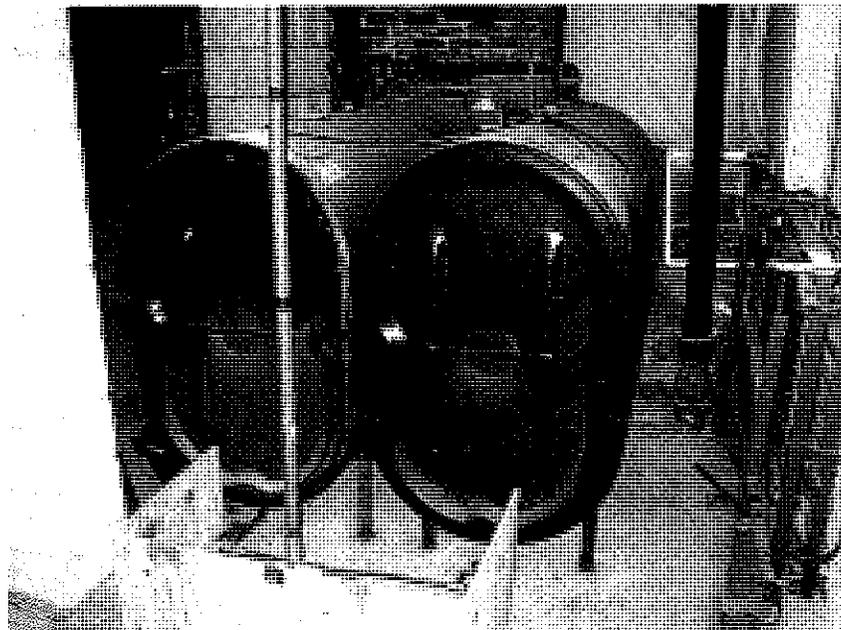
BASEMENT FUEL OIL TANKS

- Plywood Protection Skirt at Exposed Piping and Valves
- Existing Sewer Entrance
- Newer CMU Structural Piers (Left)
- Mattress to Block Basement Window Opening (Upper Right)

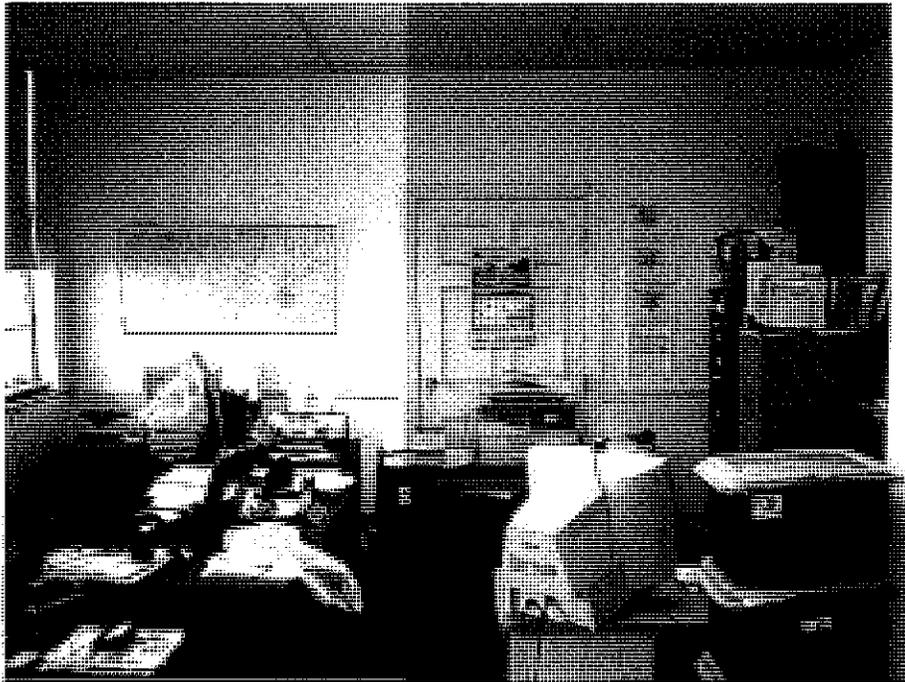
FIRST FLOOR OFFICE

- Previous Newer Finishes Include Gypsum Wallboard, Suspended Ceiling, Lighting, Chairrail, Door, Carpeting

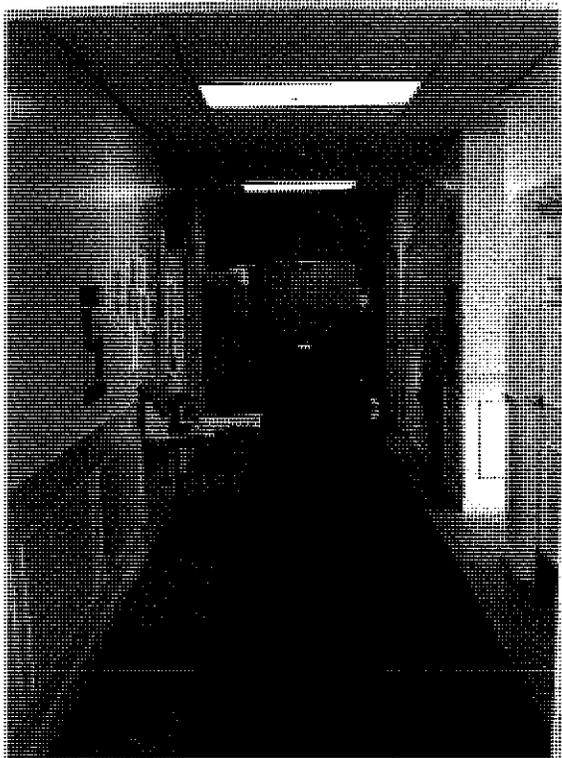
FIRST FLOOR CORRIDOR

- Previous New Finishes Include Gypsum Wallboard, Suspended Ceiling Lighting, Wainscoting, Doors, Vinyl Tile Flooring

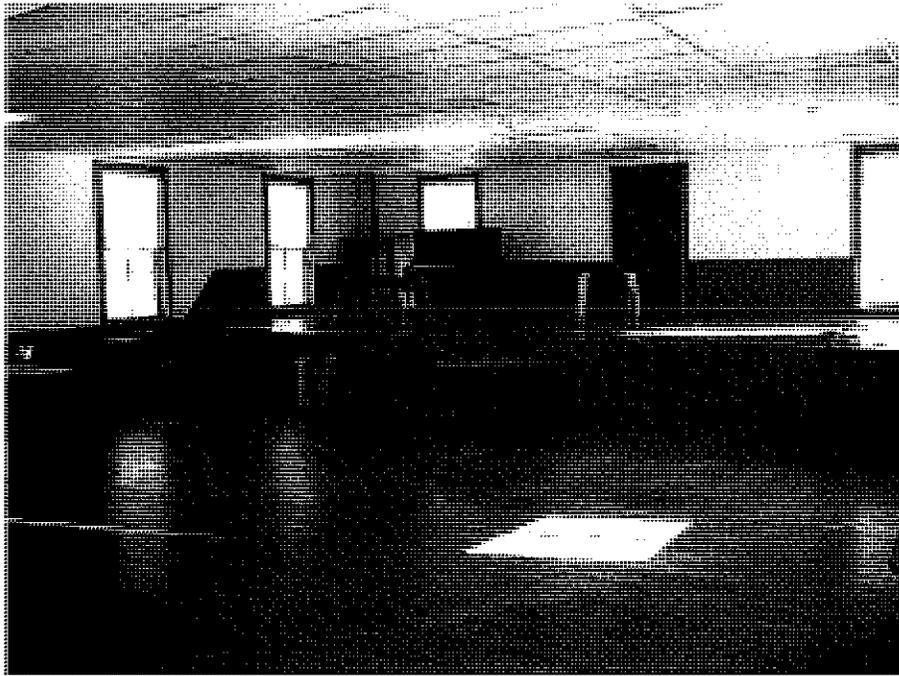
SECOND FLOOR MEETING ROOM / STAGE

- Previous Installed Suspended Ceiling / Lighting
- Low Window Sill Height at Stage

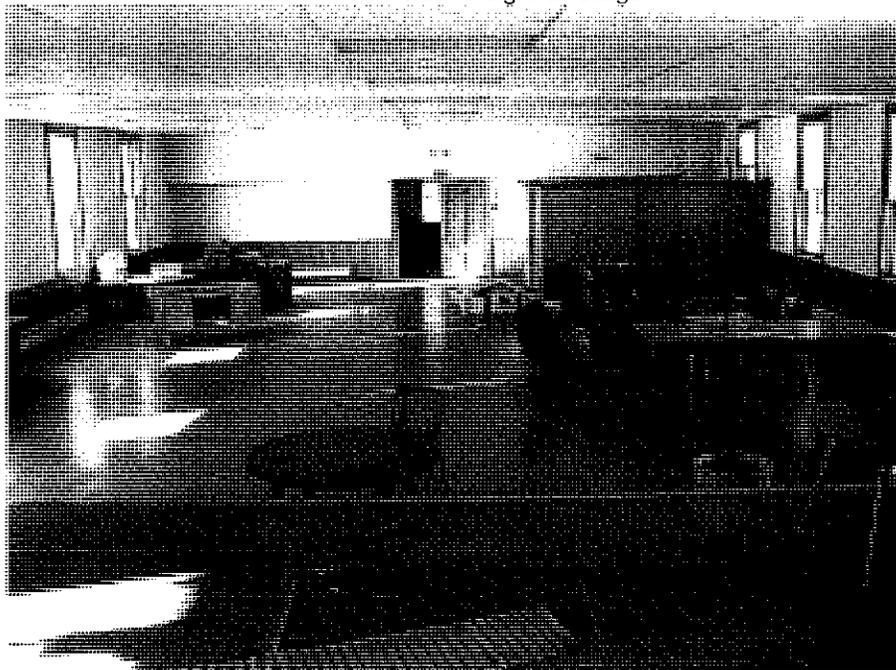
SECOND FLOOR MEETING ROOM / STAGE

- Previous Installed Suspended Ceiling / Lighting
- Temporary Wood Partitioning
- Previously Installed Perimeter Hydronic Baseboard

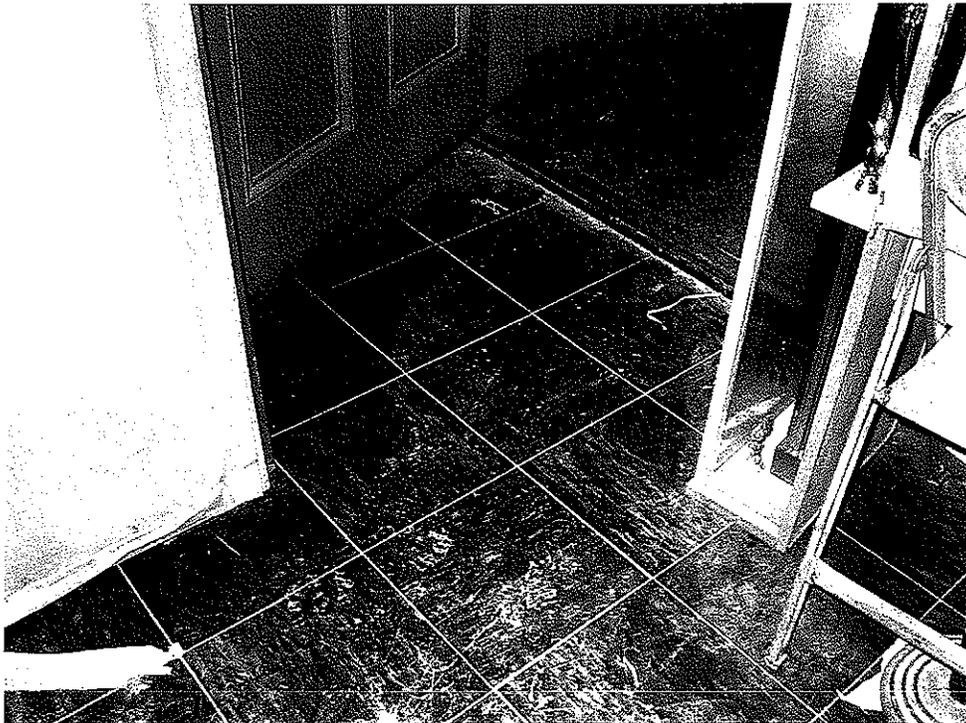
SECOND FLOOR OFFICE

- Probable Vinyl Asbestos Floor Tile
